Failure Analysis and Optimisation of Tube Water Cooler of Hydropower Plant

Abstract-- A shell and tube cooler is used to cool the cooling water of oil cooler. This cooling water of the oil cooler cools the oil that lubricates the generator thrust and guide bearings, turbine guide bearing, and the governor oil sump tank at a hydroelectric unit, in a closed system. Cooling water is treated water while a cooler fluid in shell and tube is raw water with an open circuit. The debit of treated water and raw water is 37.8 m³/hr and 54m³/hr respectively. Allowable pressure drop for the two fluids is 1.6 mWS for treated water and 0.3 mWS for raw water respectively. Treated water flows through the tube side with inlet and outlet temperatures of 42°C and 38°C, whilst the raw water flows through the shell side with inlet and outlet temperatures of 30°C and 32°C. The cooler tube is made of copper with a purity of 99.9%. and is designed to operate for 5 years. The shell and tube cooler has been in operation for 2 years and suffered damage (leaks) in tubes under the shell inlet nozzle, in the top row. Damage in the form of a large tear having with local deformation, corrosion and fouling was obse

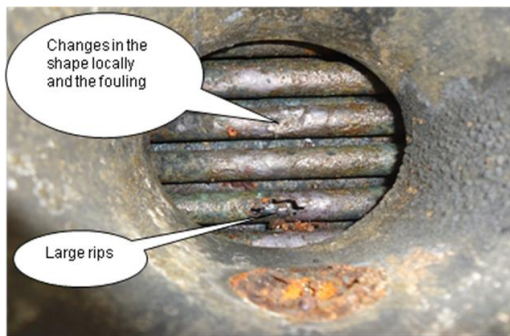
Fig. 1.3. Photos of the damaged tube [2]

From visual observation, the location of the damage is on the first row of the tube just below the shell inlet nozzle (see Figures 1.3 and 1.4). This damage may be caused by a shell inlet nozzle ρV^2 exceed the allowable value.

Based on visual data (Figure 1.3), damage in the form of a large tear, local deformation due to the depletion of materials, corrosion and fouling presence is present. Initial analyzes of the damage is as follows:

Most tube damage occurred in the first row under the shell inlet nozzle (Figure 1.3). From the type of damage, it is not caused by flow-induced vibration, but caused by the pV^2 at the shell inlet nozzle exceed the permitted values (see Table 1.1). Besides the mechanical factors, tube damage also occurs due to erosion-corrosion attack, (the reaction between the copper tube and the water as a cooling medium).

- Installation of impingement plate as shown in Figure 4.1.
- Constant flow velocity setting.

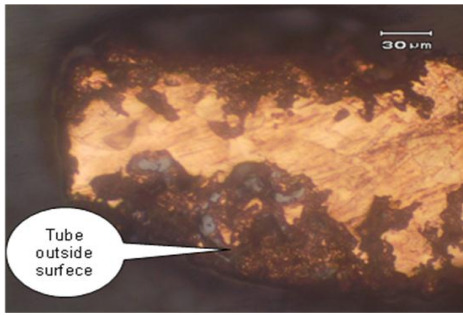
Fig. 3.2. Metallographic test results obtained from sampling point 1 (Etching: 2gr K₂Cr₂O₇ + 8 ml H₂SO₄ + 4 ml saturated NaCl _100 ml H₂O).

Metallographic tests conducted on Cu material in a damaged area using ASTM E 407-93 test method. The test results are known Cu sample microstructure consists of matrix- α . Seen also any indication of corrosion damage and corrosion erosion surface, as shown in the following figure (Figure 3.2 – 3.6)

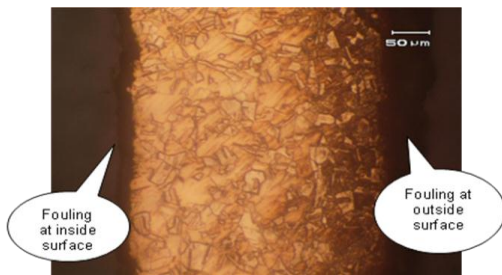
Fig. 3.4. Metallographic test results obtained from sampling point 3 (Etching: 2gr K₂Cr₂O₇ + 8 ml H₂SO₄ + 4 ml saturated NaCl _100 ml H₂O).

Peeling of film coating on the surface of the tube and continuous collision resulting in a rough surface and is a beginning of the erosion-corrosion. This phenomenon causes pitting corrosion-erosion (Figure 3.5 and 3.6). This event took place repeatedly resulted in depletion of tube surface, and leakage. The explanation that the film should be formed when copper corrosion reaction present is shown from the results of metallographic tube samples that are stored in atmospheric conditions (Figure 3.4).

cathodic	corrosion
G	Selective Corrosion	<ul style="list-style-type: none"> Occurs when one component phase elements in the alloy is a solution or corroded. Example; dezincification on brass 	<ul style="list-style-type: none"> Selective corrosion occurs on the surface of tube (see Figure 3.4)
H	Erosion-corrosion	<ul style="list-style-type: none"> Combination destruction occurs in the form corrosion and erosion of metal by fluid flow Abrasive particles that will erode the oxide layer so that the protective layer loss and the corrosion process will be faster 	<ul style="list-style-type: none"> From Figure 3.5 there appears to be abrasion and erosion of metal by fluid flow. From the test water sample known to many abrasive particles, including the type of corrosion mechanism B
I	Fatigue corrosion	<ul style="list-style-type: none"> Damage caused by a combination of mechanical (fatigue) and the environment (corrosive) so the damage becomes faster 	<ul style="list-style-type: none"> There is no indication of corrosion fatigue

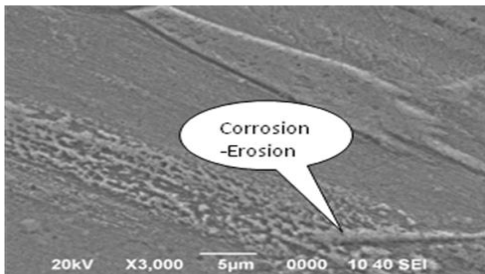
Fig. 3.5. SEM micrograph obtained from sample 2

From the results of SEM and EDAX test for sample 2, found elements of O and Cu respectively 1.3% and 98.7% in percent of mass.

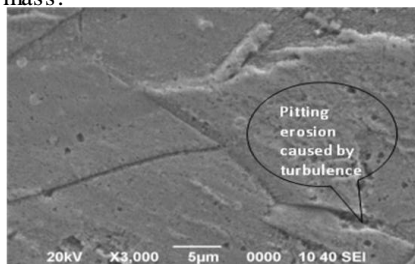
Fig. 3.6. SEM micrograph obtained from sample 3

From the results of SEM and EDAX test for sample 3, found elements of C, O and Cu respectively 11.6%, 24.3% and 85.16% in mass percent

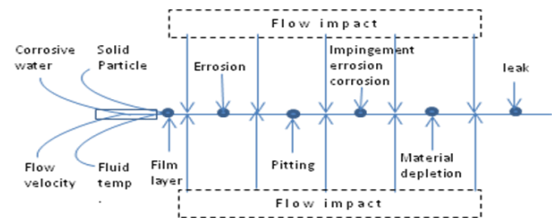
Fig. 3.7. Mechanism of erosion-corrosion tube damage

The mechanism of the erosion-corrosion damage can be seen schematically in the fishbone diagram (Figure 3.7).

Corrosive water containing solid particles (see Table 3.1) which flows through the shell inlet nozzle at high speed, hit the first line of the tube surface. This causes the film coating (corrosion reaction product) should be formed, had drifted due to flow velocity.
