# The Effect of Physical Changes in a Furnished Indoor Environment on Wireless Local Area Network (wlan) Signals

**Abstract-- This paper describes the investigation of the effect on the Wireless Local Area Network (WLAN) signals due to fixed and non-fixed variables in indoor environment. The measurement system consisted of a spectrum analyzer and a log-periodic antenna. Line-of-sight (LOS) and non-line-of-sight (NLOS) propagation (in furnished rooms) were discussed. All the measurement sites mentioned in this paper are located in the Division of Information Technology at Universiti Putra Malaysia. The furnished rooms included a teaching laboratory, a computer laboratory, and an operating office plus a server room. The effects of the various types of materials at the measurement sites also are described here.**

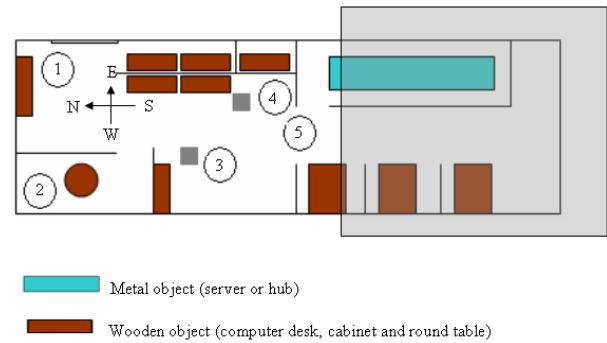
Fig. 8. Plan of Site D

Site D is the Network Operating Room where five measuring positions were chosen (Figure 8). There are two concrete pillars in the center of the room similar to Site A, B and E. Computers, computer desks, and chairs are located there. There is hard partition in Site D that was not present in Site A, B, C and E.

Five positions were chosen as measuring sites in site D. It was found that the signal could not be detected by the spectrum analyzer in the server-room region of Site D (Figure 9), which is represented by the gray area in Figure 8. The gray area is farther from the transmitter than any other part of the Network Operating Room. The corridor after position 5 is like a tunnel (Figure 10). It was assumed that there was no direct signal in the gray shadow region and that the signal was weak (i.e.

The arrangement of furniture in Site D was not as crowded as in Site A and B. Therefore, the scattering effect was not significant in Site D. Even though there are soft partitions in Site D, they did not contribute to the problem of scattering in this site because the transmitting antenna was located higher than the soft partitions, and the receiving antenna was located some distance from the soft partitions. As a result, the ray path was not blocked by the soft partitions.

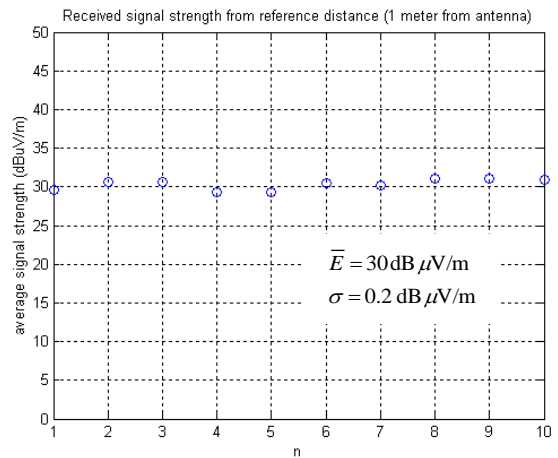
Fig. 13. Variation of the strength of the received signal for each measurement

Note: Sample measurement on the n<sup>th</sup> day (The notation ‘n’ will be used in following figure.)

Figure 13 shows the variation of the strength of the received signal which was measured 20 times/days at one meter from the antenna (reference signal strength). Figure 13 was used to study the repeatability of the data [6]. The reference distance (one meter) was used to normalize the path loss that occurred at one meter from the antenna so that only the propagation effects and the radiating (or far-field) effects are considered in the path loss [7]. The Rayleigh distance must be calculated to determine the boundary of the near field and the far field of the transmitting antenna:

The mean value of the strength of the received signal that was obtained from 10 measurements at different times and reference positions from the antenna was around 30 dB  $\mu$ V/m. This value represents the strength of reference signal. Losses in the strength of the signal that occurred beyond this point were purely distance-dependent, due to the obstacles that blocked the signal, or interference from multi-path fading.

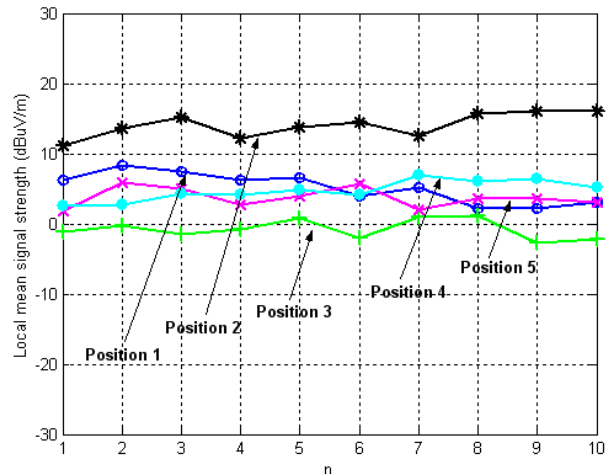
Fig. 15. Variation of the strength of the received signal at the time of each measurement at Site A

Figure 15 represents the variation of the mean strength of the signal for all of the positions (positions 1 through 5) for 10 different sets of measurements.

Since Site C is not an NLOS region, the comparison among overall results in NLOS sites, i.e., Site A (Figure 15), B (Figure 16), D (Figure 21), and E (Figure 22) indicates that only Site D provided the best performance in reception. The distance factor was dominant in Site D since this site was located closer to the transmitting antenna than other NLOS sites, and the measured distance increased from position 1 to position 5.

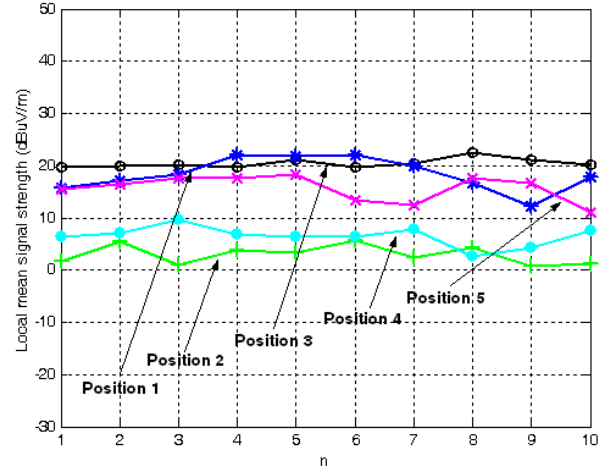
Fig. 16. Variation of the strength of the received signal at the time of each measurement at Site B

the signal had travelled a longer distance. Position 4 was closer to the transmitting antenna than position 5, but a stronger signal was received at position 5 (Figure 16) because it was blocked on by the glass wall. Compare with position 4 that is blocked by the glass wall and the concrete pillar. Similar conditions existed at positions 1, 2, and 3, making the obstruction losses dominant.

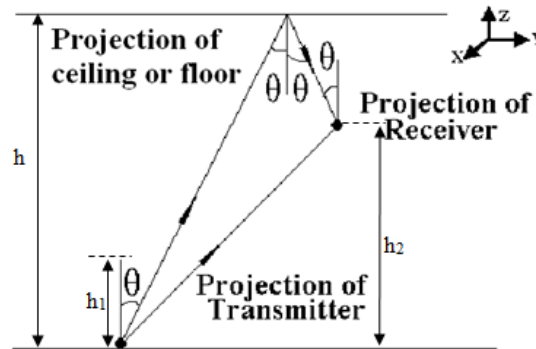
Fig. 18. Projection on the single floor

where  $h_o = h_1 \pm h_2$  (Figure 18); the positive sign is used when the total number of reflections from the ceiling and the floor is odd, while the negative sign is used when the number is even; and  $\alpha = \pm 1$ , and, as a rule of thumb, the positive value is used when the first reflection occurs from the floor, while the negative value is used when the first reflection occurs from the ceiling. Equation (3) is illustrated by Figures 18 and 19.

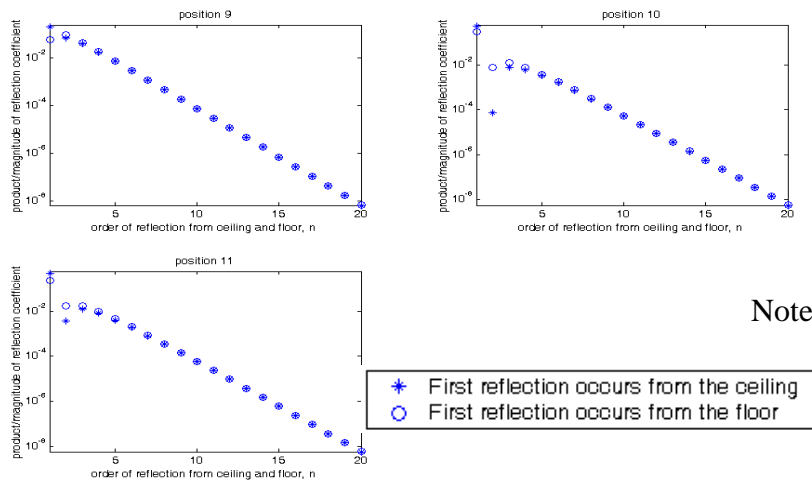
Most of the positions gave almost zero readings after the third-order multiple reflections as shown from Figure 20(a) to

Fig. 20(a). Product/magnitude of reflection coefficients after some order of multiple reflections (Positions 1 to 4)

Fig. 20(b). Product/magnitude of reflection coefficients after some order of multiple reflections (Positions 5 to 8)

Fig. 20(c). Product/magnitude of reflection coefficients after some order of multiple reflections (Positions 9 to 11)

Figure 20(c). Most of the cases in Figure 20(a) to Figure 20(c) show that the strength of the multiple reflected signals above the third order can be omitted due to their small reflection coefficients.

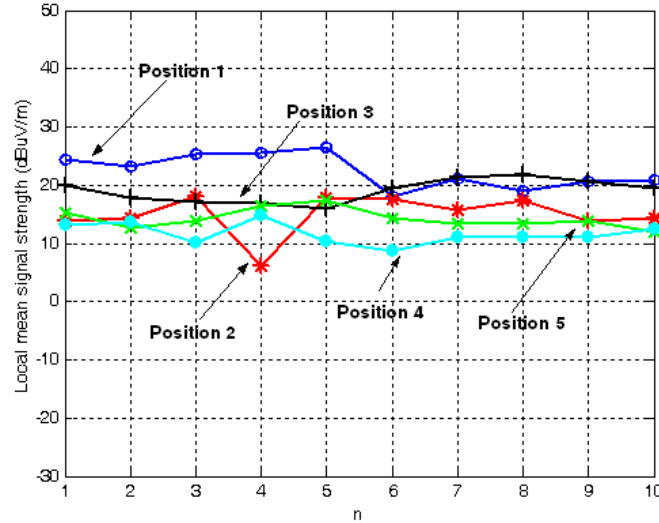
Fig. 21. Variation of the strength of the received signal each time a measurement was made at Site D

Compared to the signals received at Site A, B, C, and E, the signal received at Site D was very weak (i.e., 'buried' in the floor noise in spectrum analyzer and undetectable), as

shown in Figure 21 and Table 7. This occurred because the spectrum analyzer was unable to detect signals in some areas of Site D, e.g., where a corridor was formed like a tunnel. This is shown in the gray, shadow area in Figure 8. Multiple reflections occurred along the corridor, so the signal was weak, especially when the signal underwent multiple reflections that were higher than third order. The inner part of Site D in the shaded region (Figure 8) is the room after the corridor (Figure 10), and the spectrum analyzer results identified this as the 'blind spot' of the propagation of signal wave from the transmitting antenna (NLOS). Position 1 had the greatest mean signal strength among the positions. It is due to the factor of distance where position 1 is the closest position from the transmitting antenna. The vast difference of variability in position 2 compared with other positions was attributed to the blockage of an office (a glass and concrete wall). The NLOS signal was dominant at position 2, since the direct ray may not exist because it was blocked by a glass wall and a concrete wall in the office.
