Case Study for Solution of Ostrava-Svinov Transfer junction Aimed at Movement and Orientation of Blind and Visually Impaired People

Abstract— This paper is focused on evaluation of barrier-free accessibility of the significant regional transfer junction in Ostrava made up of the Ostrava-Svinov railway station and upper and lower stops of the urban mass transportation. The outcome is focused on solving the problems of movement and orientation of blind and visually impaired people.

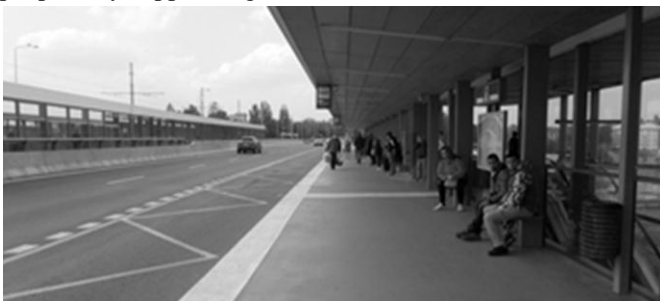
Fig. 4. Design of the boarding point surface.

Boarding points of tram and bus stops are designed in an identical way. The surface of boarding points is elevated above the carriage way (rails) by 200 mm. The surface is made of concrete, the walking area of which is painted red. The boarding edge is distinguished in a contrastive way with 400 mm wide white paint. Individual boarding points are provided with adhesive tactile signal strips in white colour. The natural guiding line here is made up of the glazed facade in the structure of which there are columns carrying the roof. These columns are protruding in the space (200-400 mm) and there are provided with seats and waste bins making problems to the blind during their movement as they are not always able to identify these elements and collision with them or with sitting people may happen (Fig. 4).

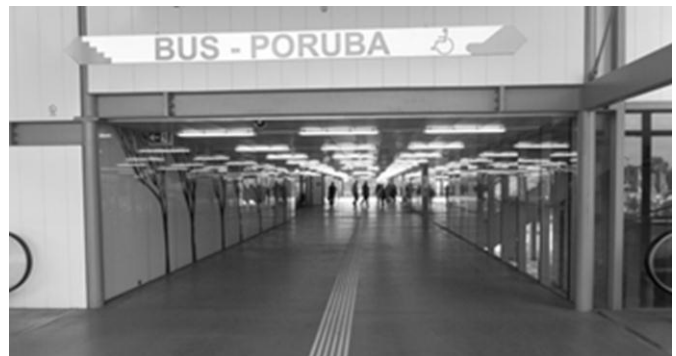
Fig. 6. Area of the central part with the artificial guiding line.

The central part of the communication area between individual boarding points is provided with a 300 mm wide artificial guiding leading through the centre of the communication with

branching to individual staircases (Fig. 6).

However, this design does not provide the blind people with sufficient tactile contrast and it becomes unreadable for them. Utilization of the natural guiding line in the form of walls of the passage is unsatisfactory in this place due to access to individual boarding points. The route of the blind would cross these directions and a collision with another passenger could happen. Another questionable element of the new areas of the transfer junction is the actual aesthetic interpretation composed of glass, concrete, and metallic (predominantly columnal) structures. The aesthetic appearance of the entire area is

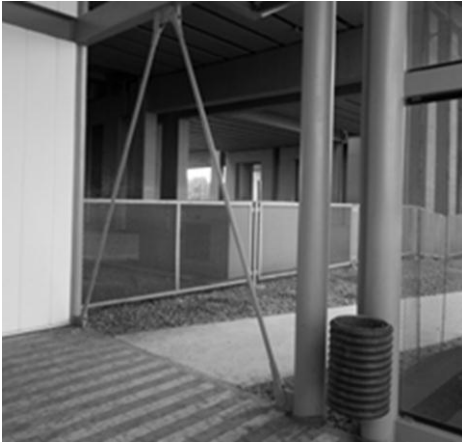
Fig. 7. Draw-bars in the communication area.

perfectly unified (the combination of white, red, black, and grey colours is repeated in it) which may cause considerable difficulties to the visually impaired people in recognition of individual areas and their functions, not speaking of glass areas where there are contrast marking in their central part (represented here by handrail). Two lifts found behind the staircases and escalators are accessible from the ground. They are accessible using a natural guiding line formed by the red facade. The lifts are in compliance with applicable regulations in terms of space and equipment (the controls are at a height of 1000-1200 mm, they are provided with Braille fonts, they contain a tilting seat, etc.). In vicinity of the lift there are draw-bars on the structure interfering with the communication area

and the blind and visually impaired people have no chance to register them with the mobility techniques they use. Thus this structure becomes very dangerous (Fig. 7).

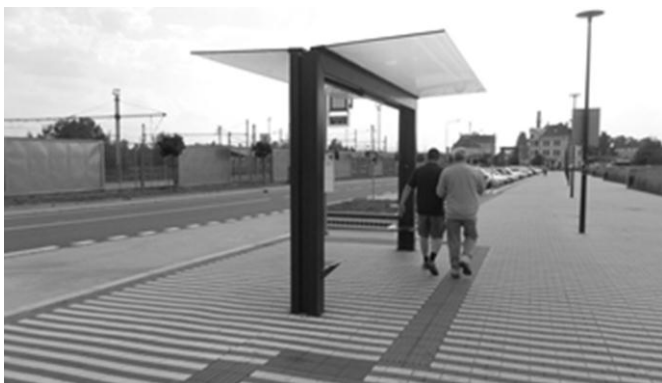
Fig. 8 Unsuitable location of the stop roof.

The entire area of the Svinov Bridges low stop is found on the ground level. Analogous to the other areas, it is made up of a uniform surface made of smooth concrete pavement in grey-white colour combination. Tactile warning elements (signal and warning strips) are made of red pavement and so they create a sufficient contrast both for the visually impaired and the blind. The artificial guiding lines here are constructed in two ways – the elevated kerb and the pavement in black colour with tactile 400 mm wide grooves which is primarily found in the area of the stops and on the footpath towards the railway station. The wrong placement of the bus stop roof is

questionable as it affects unsuitably and unnecessarily the smoothness of the artificial guiding line and makes the mobility of the blind people difficult (Fig. 8).

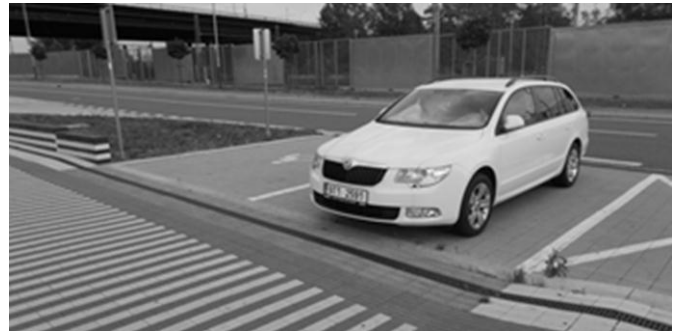
Fig. 9. Solution of the barrier-free parking stands.

The barrier-free parking stands found at the edge of the parking area are placed and designed suitably close to the stops (Fig. 9).

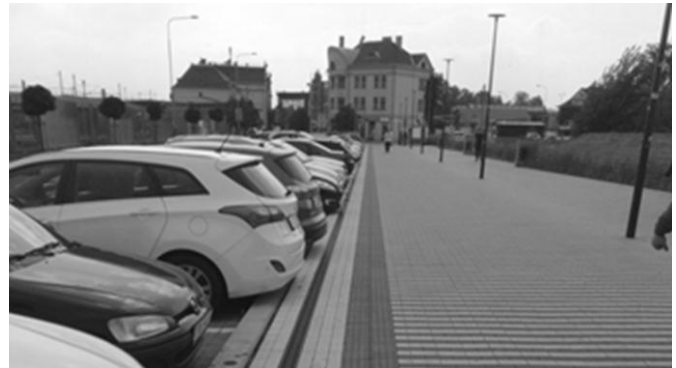
Fig. 10. Unsuitable placement of the artificial guiding line.

Another problem on the connecting pavement is taking the artificial guiding line at the edge and along the parking area. The artificial guiding line keeps the necessary 800 mm

distance from the edge of the kerb but parking cars are not prevented from overreaching into the pavement area. When the blind walks along this artificial guiding line, they can touch the parked vehicles (Fig. 10).

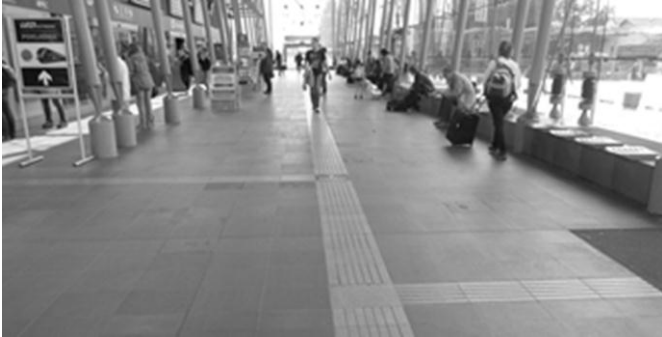
Fig. 12. Placement of the artificial guiding line.

Inside the station hall, there is an artificial guiding line created by means of grooves milled in the pavement with a contrast shade. However, the milled grooves do not provide the blind with a sufficient tactile contrast and do not fulfil its function adequately (Fig. 12).

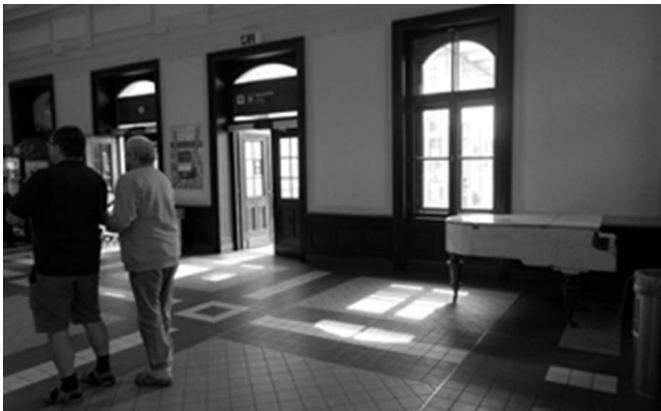
Fig. 13. Elements affecting the natural guiding line.

Another disputable issue is the connection of the new and old parts of the building. In the premises of the old station building, no artificial guiding lines are designed owing to historical value of the premises and the blind are oriented in the area only according to natural lines (walls) that are not fully adapted to this use. In many places there are elements causing barriers and obstacles (advertising stands, piano, etc.) complicating the blind their fluent walking (Fig. 13).

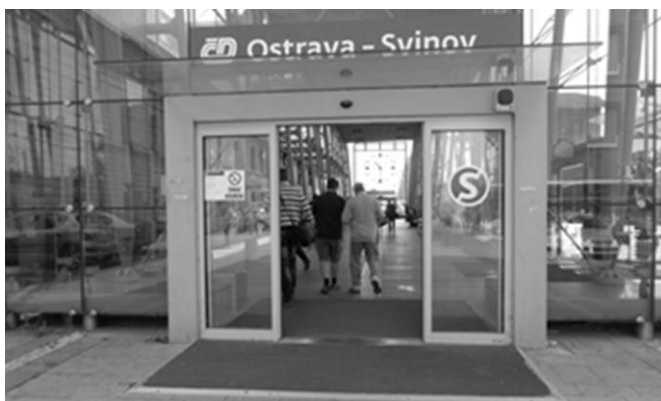
Fig. 11. Unsuitably placed acoustic beacon.

The area in front of the railway station building lacks contrasts and tactile elements which would guide the blind and visually impaired people. The entrance to a newly built area of the railway station is provided with a wrongly installed acoustic beacon which will not guide the blind towards the axis of the entrance door (Fig. 11).
