Failure Analysis and Optimisation of Tube Water Cooler of Hydropower Plant

Abstract-- A shell and tube cooler is used to cool the cooling water of oil cooler. This cooling water of the oil cooler cools the oil that lubricates the generator thrust and guide bearings, turbine guide bearing, and the governor oil sump tank at a hydroelectric unit, in a closed system. Cooling water is treated water while a cooler fluid in shell and tube is raw water with an open circuit. The debit of treated water and raw water is 37.8 m³/hr and 54m³/hr respectively. Allowable pressure drop for the two fluids is 1.6 mWS for treated water and 0.3 mWS for raw water respectively. Treated water flows through the tube side with inlet and outlet temperatures of 42°C and 38°C, whilst the raw water flows through the shell side with inlet and outlet temperatures of 30°C and 32°C. The cooler tube is made of copper with a purity of 99.9%. and is designed to operate for 5 years. The shell and tube cooler has been in operation for 2 years and suffered damage (leaks) in tubes under the shell inlet nozzle, in the top row. Damage in the form of a large tear having with local deformation, corrosion and fouling was obse

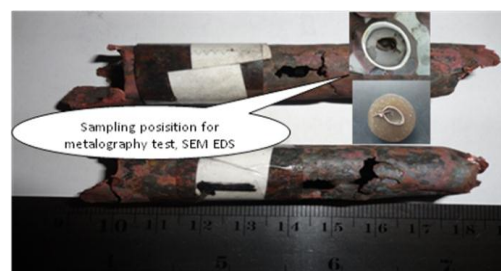
Fig. 2.1. Samples for Testing Materials

For the purposes of the material test, the sample of material is taken at damaged tube (the shell inlet nozzle area, tube top row) as shown in Figure 2.1 and 2.2.

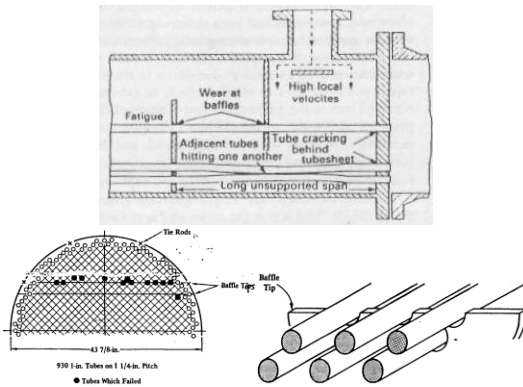
Fig. 3.1. Location of Damage [6]

- a. The damage was not caused by the phenomenon of flow-induced vibration (vortex shedding, turbulent buffeting, fluid-elastic whirling, ..) that can cause damage in the form of collision damage, baffle damage, fatigue, tube joint failure as usually shown in Figure 3.1
